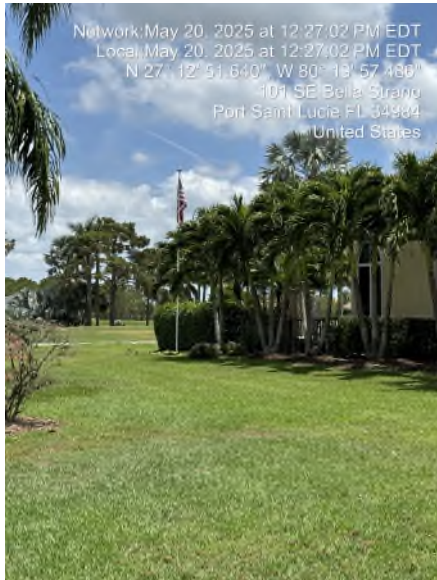
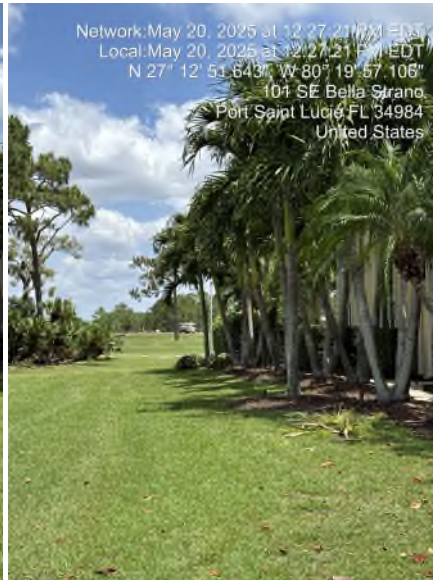
Address	Reported issue	Cdd inspection results
1. 101 Se Bella Strano	Planted a line of Christmas palms and a new flagpole outside of fence line along cdd lake area buffer zone	This property belongs to the "Tesoro club properties LLC" and does not encroach on CDD maintenance area

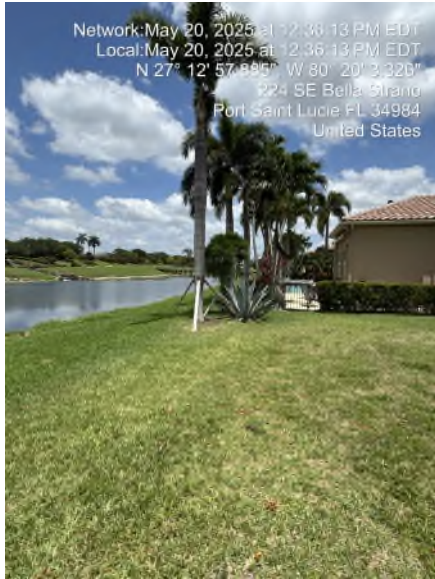
2. 224 Se Bella Strano	Planted royal palms on CDD property outside the fence line	The palm tree is planted on the lot next door address "226 se Bella Strano"

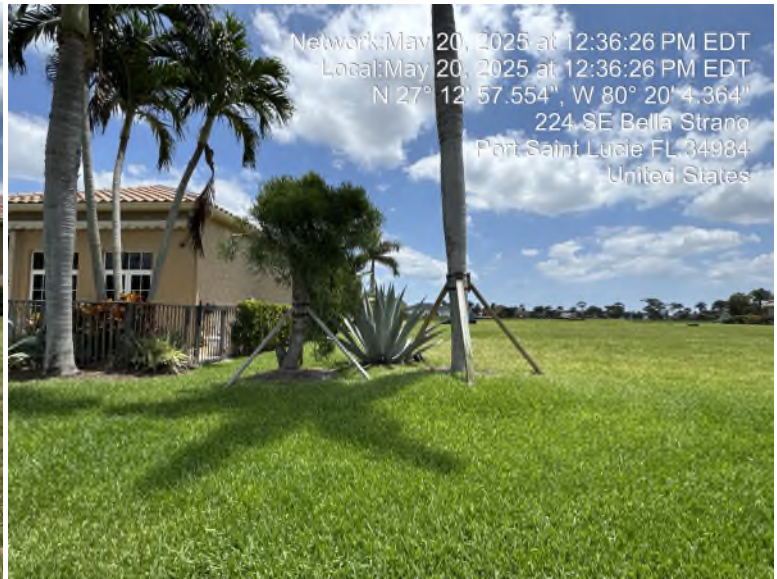
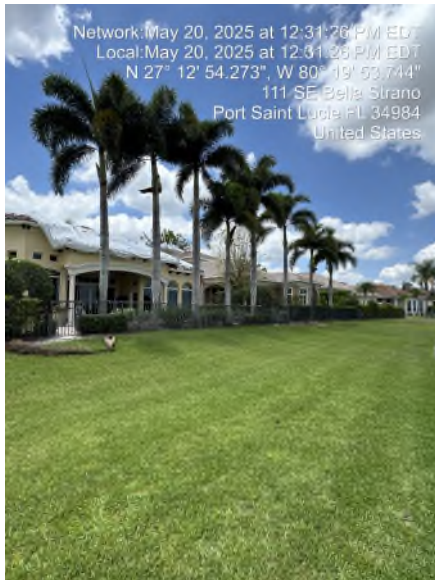
3. 111 Se Bella Strano	Planted royal palms on CDD property outside the fence line.	No tree in the location mentioned
4. 145 Se Rio Angelicia	Entire rear of the property	It did not appear as if cdd property was being encroached on here

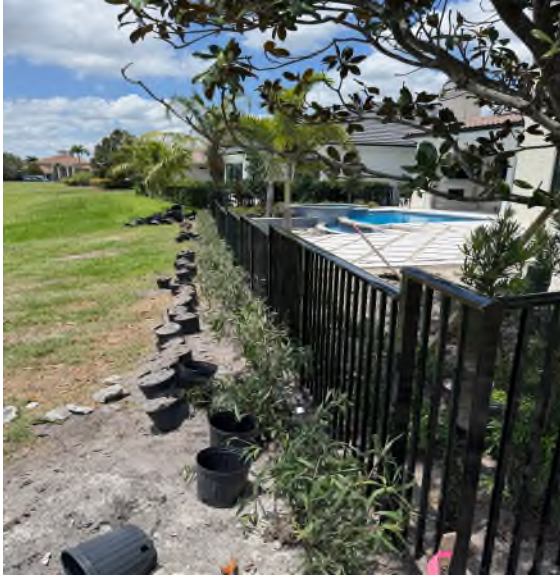
5. 203 Se Bella Strano	Planted a magnolia tree and new runoff drainage into CDD property	No magnolia tree or any added drainage was found near this property

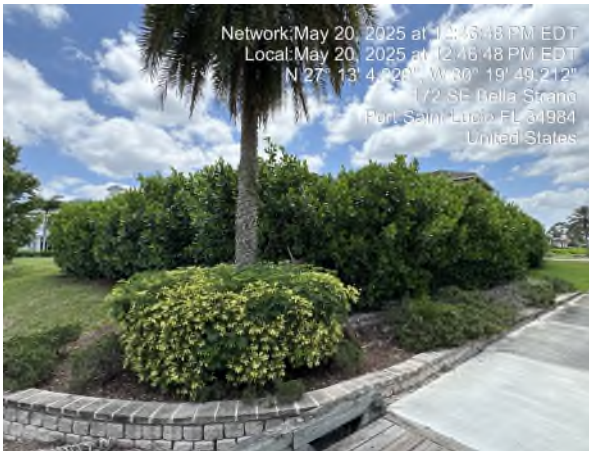
6. 172 Se Bella Strano	Has plants on CDD property adjacent to the rear property boundary	All plants appeared to be planted on the homeowners properly, the shrubs have grown and may have grown past the property lines

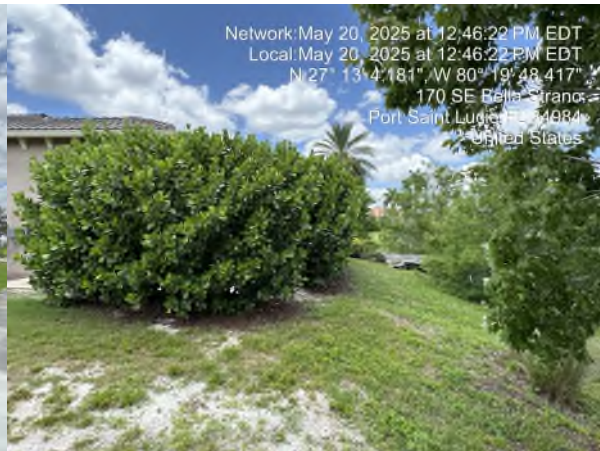
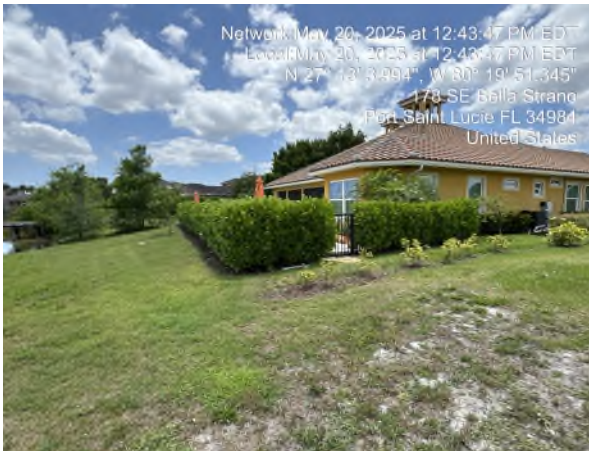
7. 174 Se Bella Strano	Added a pool deck, fence and plants within the buffer zone, extending past property line	All plants appeared to be planted on the homeowners properly, the shrubs have grown and may have grown past the property lines

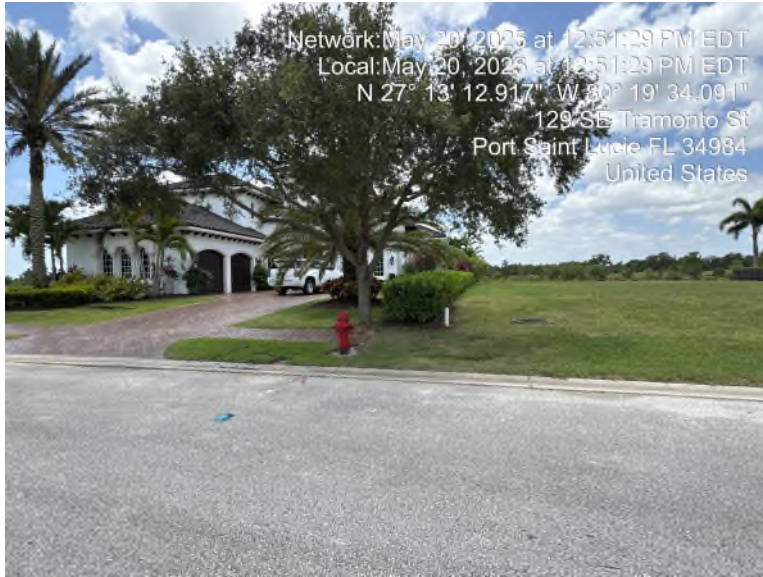
8. 130 Se Tramonto	Westside hedge over property line	The hedge is not located on cdd property it may be on the neighbors lot "126 se Tramonto"
9. 147 Se Rio Angelica	The west side hedge and leisure path	The hedge is not located on cdd property it may be on the neighbors lot "149 Se Rio Angelicia"

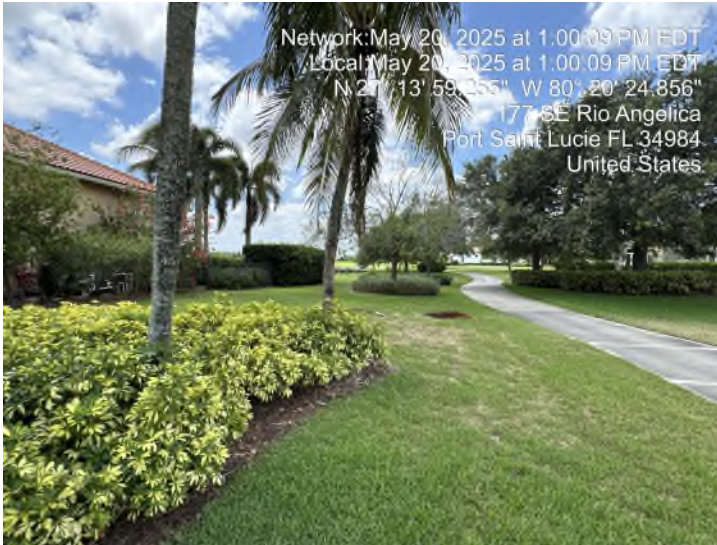
10. 177 Se Rio Angelica	Hedge by cart path on the east side	Not encroaching on cdd property maybe on "Tesoro club properties llc" property
11. 108 Se Rio Siena	Entire 140-foot side of property	No cdd property located adjacent to this address

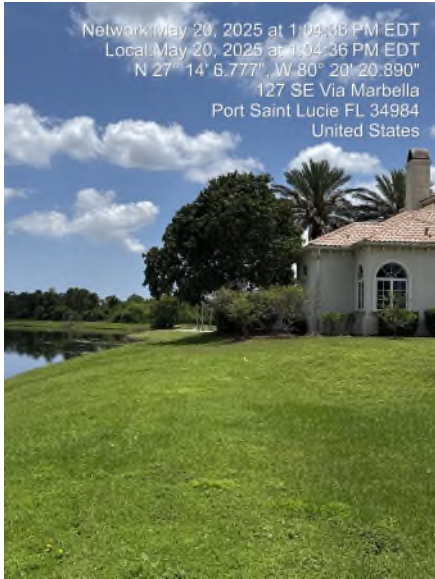
12. 131 Se Via Marbella	Rear and 149 foot side of property	Does not appear to be encroaching on cdd property
13. 142 Sw Via San Marino	Entire rear including 61 ft and of property	Does not appear to be encroaching on cdd property

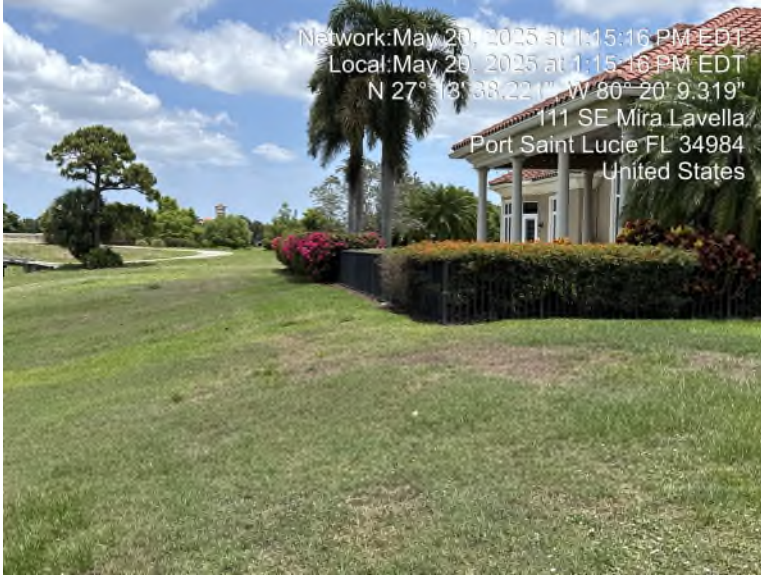
14. 109 Se Via Lavella	Entire hedge in rear of property	Hedges planted on the homeowners side of the property line and has partially grown through the fence

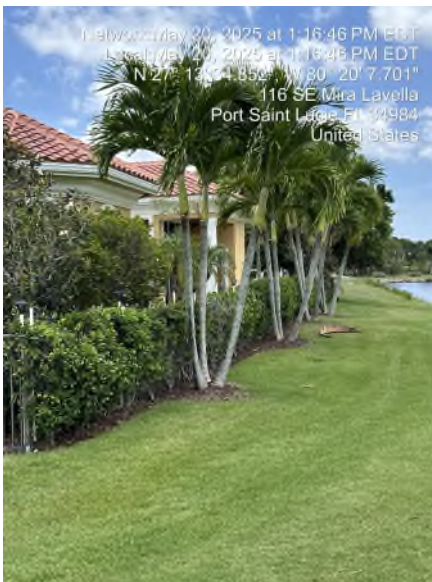
15. 114 Se Via Lavella	Palm trees behind the property	Palm trees located on homeowners property or possible encroaching "Tesoro club properties LLC"
16. 128 Se Rio Angelica	Pulling water from lake	The pump and pipe are scheduled to be removed
17. 132 Se Rio Angelica	Pulling water from lake	The Pump and pipe have been removed
18. 133 Se Mira Lavella	Pulling water from lake	House inspected no evidence was found
19. 108 Se Santa Lucia	Pulling water from lake	House inspected no evidence was found
20. 288 Se Fascio Circle	Pulling water from lake	House inspected no evidence was found
21. 138 Se Via San Marino	Pulling water from lake	House inspected no evidence was found
