## Tesoro CDD

### 2026 Q1 Community Note

#### *Retention Ponds*

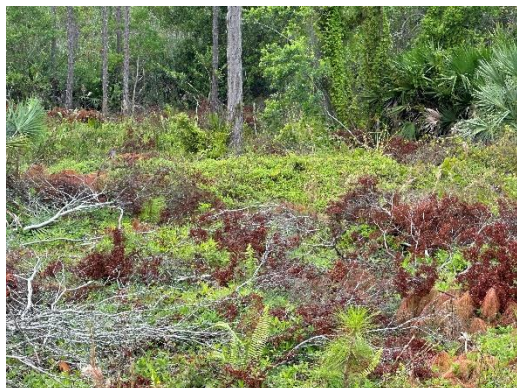
Prior Condition

Their condition was poor, as the photos show, and offer little of the retention capability we require. The photos depict as they were some months ago, then after cleaning the rough outline of the basin and the overflow structure. The last 2 show the recreated basin and the cleared grate which allows the water from the roadway to enter the pond.

The first 2 ponds have been rebuilt. The walls have been remade and the floor of the pond dug down to the correct depth, after removing all the last 15 plus years of silt and debris. The earthen berm walls are left to settle and in the coming month or so, weather permitting, we will grass the walls and hydra seed the base. This will turn this into a permanent retention capability for the future. We intend to do maintenance on these regularly to ensure these remain in good condition, which is very different from the process of the last 15 years. This is not an insignificant amount of work or cost, and there are well over a dozen of these areas that require attention of some sort, from rebuilding to improving walls for example. This is another essential project and cost.
