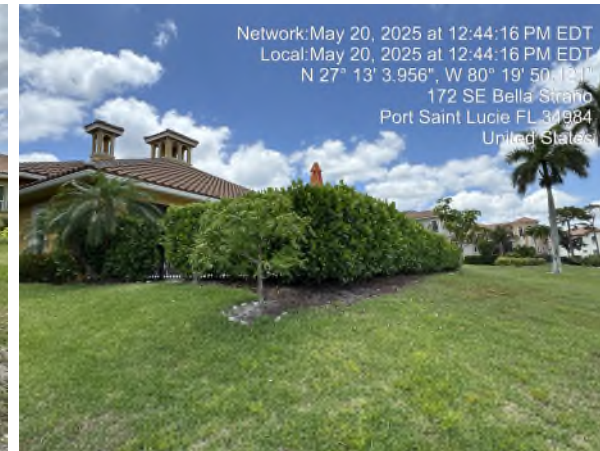
7. 174 Se Bella Strano	Added a pool deck, fence and plants within the buffer zone, extending past property line	All plants appeared to be planted on the homeowners properly, the shrubs have grown and may have grown past the property lines
